Better Teamwork Lifts an Aussie Icon!

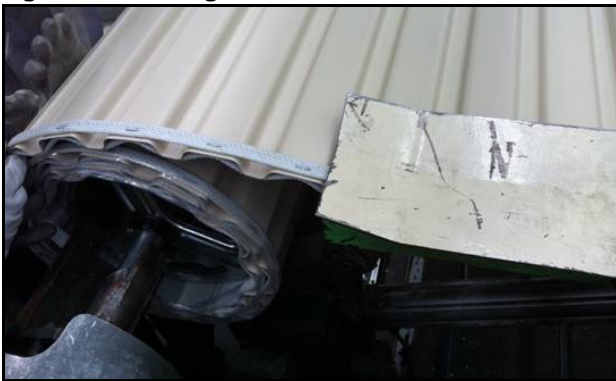
Figure 3 – 'Coning'

If the door is not rolled correctly, 'coning' occurs leading to rework and scrap

An example of this was the "Coning" issue. Possible causes were listed as either equipment related, material related or people related. When all the equipment related issues were addressed it was seen that there was still a percentage of the problem occurring.

Further investigation showed key differences in how experienced Operators performed the process as compared to 'new starters' or Operators transferred from different lines. The critical elements of the process were identified, documented and reinforced in a Visual Work Standard.

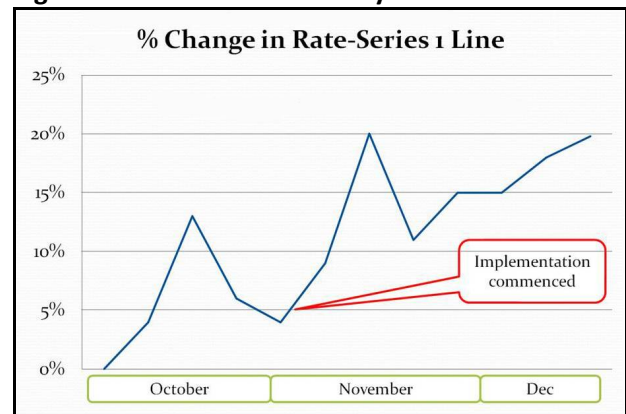
Figure 4 – Series 1 Productivity Results

- There was a **19.8% improvement** in productivity from the previous 3 month average (Aug – Oct) to the achieved rate in mid December. If this rate can be maintained the annualised improvement against budget will be over **\$63,000**.
