Beating Industry Standards at Coopers!

At Coopers Brewery, it is as important to improve the benchmark as it is to reach for it. With their dedication to continuous improvement the Regency Park site in South Australia continue to push the boundaries to stay ahead of the pack.

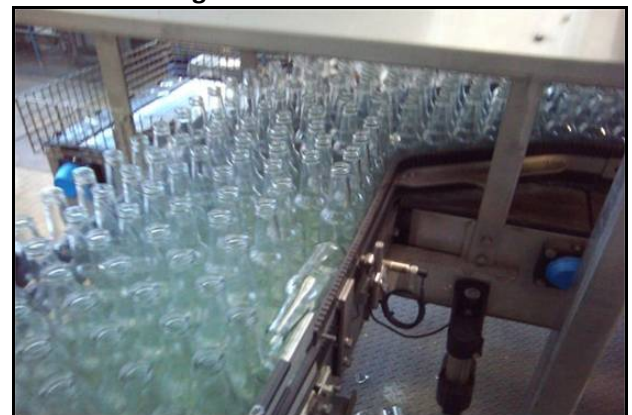
Figure 1: Fallen Clear bottles between 1st and 2nd 90 degree bends

- Clear bottles – De-palletiser side back corner, bottle falls (look at possibly stopping conveyor before Flap opens).
- Gaps from De-palletiser – Fallen Clear bottles between 1st and 2nd 90 degree bends (Line speed is too fast causing many fallen bottles, refer to Figure 1).
- Fallen bottles and cans inside Pasteuriser.
- Uneven belts flowing from 2 conveyors to 1 conveyor (behind past panel).
- Stainless Electrical conduit cover is a bottle jam point (refer to Figure 2).
- No back-up sensor on out-feed of Packer to stop machine if a carton jams at Rejecter / Carton Turner.
- Device to stop incorrectly turned cartons on the Palletiser.
