"The Shift"

Refinery Area Based Team

Operator Equipment Management Step 2 Edition 7

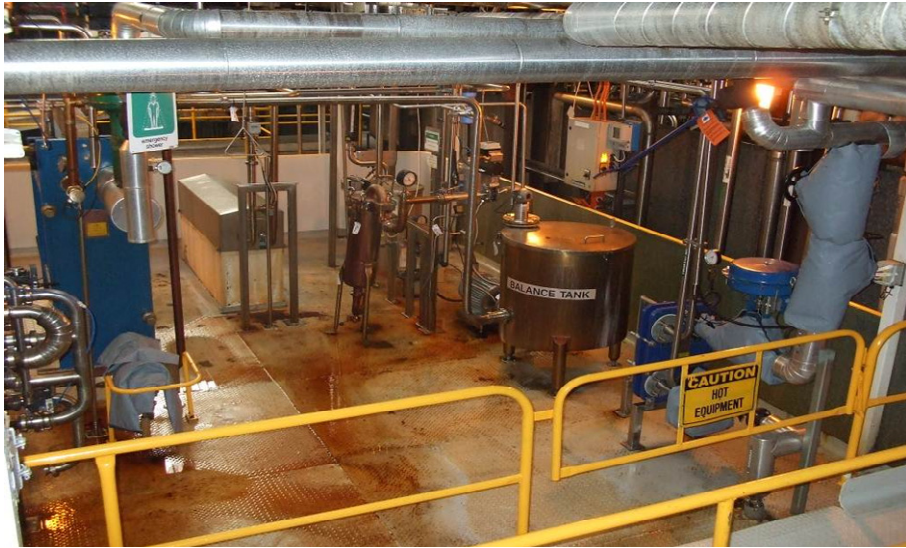
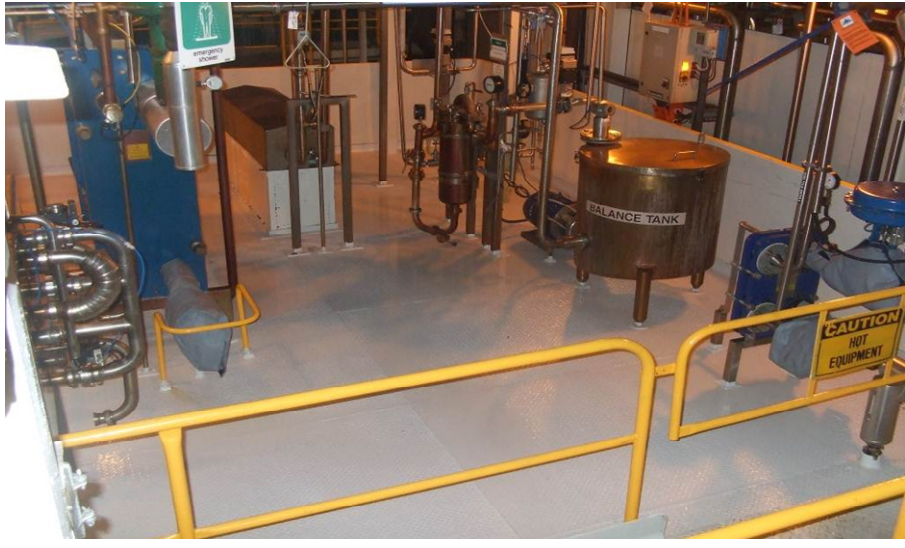
Team Name:	THE SHIFT	Location:		Initiated Date:	29/2/12
Team Type:	OEM 2	Item:	Liquid Sugar Plant	Completed Date:	5/5/12
Initiator:					
1. Problem					(Plan)
Contamination, leaks and corroded floor and wall.					
2. Current Situation			3. Proposed Change / Approved Improvement		
(Plan)			(Do)		
Photo:			Photo:

Improvement Target:	Identify and fix leaks and contamination issue's, Thorough clean up and re paint.		Cost:	\$3000	Expected Saving: N/A
4. Results:			5. Future Actions:		
(Check)			(Act)		
Leaks and contamination issue's sorted, dry floor and Plant repainted.			Plant included in checklist for regular maintenance.		
CTPM Australasia	Approved by:	Shift A	Shift B	Shift C	Shift D
	Team Leaders to sign off acceptance of Proposed Change

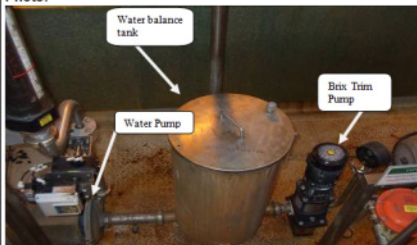
TPM ³ Improvement Sheet														
Team Name:	The Shift	Location:	PLS Plant water supply pumps	Initiated Date: 23/4/12										
Team Type:	OEM 2	Item:	PLS Plant water supply pumps	Completed Date: 23/5/12										
Initiator:	TGRB													
1. Problem (Plan)														
PLS mixing losing water supply, Water tank overflowing, multiple leaks, high cost of running and maintaining the plant.														
2. Current Situation (Plan)														
Photo:

3. Proposed Change / Approved Improvement (Do)														
Improvement Target: Simplify plant by removing water supply and brix trim pumps including tank. Water supply directly feed from existing main line via pressure regulator.														
Cost:														
Expected Saving:														
4. Results: (Check)														
Reduced operating and maintenance cost, Plant running more stable, Leaks eliminated, Easy to maintain.														
5. Future Actions: (Act)														
<table border="1"> <tr> <td>Approved by:</td> <td>Shift A</td> <td>Shift B</td> <td>Shift C</td> <td>Shift D</td> </tr> <tr> <td>Team Leaders to sign off acceptance of Proposed Change</td> <td></td> <td></td> <td></td> <td></td> </tr> </table>					Approved by:	Shift A	Shift B	Shift C	Shift D	Team Leaders to sign off acceptance of Proposed Change				
Approved by:	Shift A	Shift B	Shift C	Shift D										
Team Leaders to sign off acceptance of Proposed Change														
CTPM Australasia				Page 15

6. Evaluate Results - Evaluate the results of the improvements made (Check)																																	
<p>Test conducted with water supply direct from Regulator and isolating both water pump and Brix trim pump. Results very encouraging, brix + flow stable. Flow rate can be varied to minimum to max 1/min.</p>

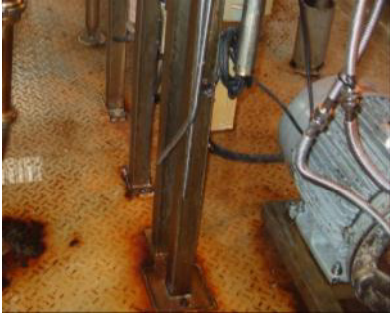
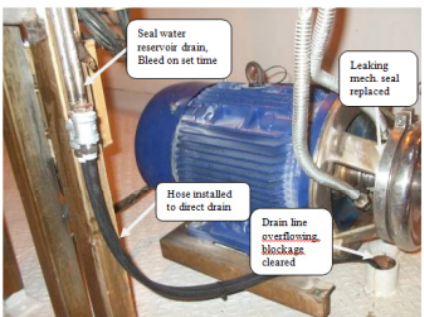
TPM ³ Improvement Sheet			
Team Name: The Shift		Location: PLS Plant	
Team Type: RB		Initiated Date:	
Initiator: RB		Completed Date:	
1. Problem (Plan)			
2. Current Situation (Plan)		3. Proposed Change / Approved Improvement (Do)

4. Develop Root Cause Solutions - Summary Result of Root Cause Analysis (Plan)																															
<table border="1"> <thead> <tr> <th>Cause 1:</th> <th>Cause 2:</th> </tr> </thead> <tbody> <tr> <td>Seal water reservoir bleeding</td> <td>Cracks on Roof</td> </tr> <tr> <td>Possible Solutions:</td> <td>Possible Solutions:</td> </tr> <tr> <td>• Re-direct water bleed to drain</td> <td>• Replace roof</td> </tr> <tr> <td>• Clean / wash tank drain</td> <td></td> </tr> <tr> <td>• Replacing seal</td> <td></td> </tr> <tr> <td>• Drop pump to 90°</td> <td></td> </tr> </tbody> </table>								Cause 1:	Cause 2:	Seal water reservoir bleeding	Cracks on Roof	Possible Solutions:	Possible Solutions:	• Re-direct water bleed to drain	• Replace roof	• Clean / wash tank drain		• Replacing seal		• Drop pump to 90°

Improvement Target: Identify and fix all leaks		Cost: Expected Saving:	
4. Results: (Check)		5. Future Actions: (Act)	
Floor dry, safer workplace

• Drop pump to 90°																															
5. Implement Solutions - Summary of action completed (Do)																															
<table border="1"> <thead> <tr> <th>Proposed Actions / Approved Actions</th> <th>Who</th> <th>Proposed Date</th> <th>Completed Date</th> </tr> </thead> <tbody> <tr> <td>Fit a drain hose on Reservoir</td> <td>RB</td> <td>6.6</td> <td></td> </tr> <tr> <td>Unblock drain line</td> <td>CS</td> <td>6.6</td> <td></td> </tr> <tr> <td>Replace mechanical seal</td> <td>Logan</td> <td>12.6</td> <td></td> </tr> <tr> <td>CIP pump set to 90°</td> <td>RB</td> <td>6.6</td> <td></td> </tr> <tr> <td>Replace drainage roof</td> <td>RS</td> <td>6.6</td> <td></td> </tr> </tbody> </table>								Proposed Actions / Approved Actions	Who	Proposed Date	Completed Date	Fit a drain hose on Reservoir	RB	6.6		Unblock drain line	CS	6.6		Replace mechanical seal	Logan	12.6		CIP pump set to 90°	RB	6.6		Replace drainage roof	RS	6.6

6. Evaluate Results - Evaluate the results of the improvements made (Check)																															
Water on floor significantly minimised.

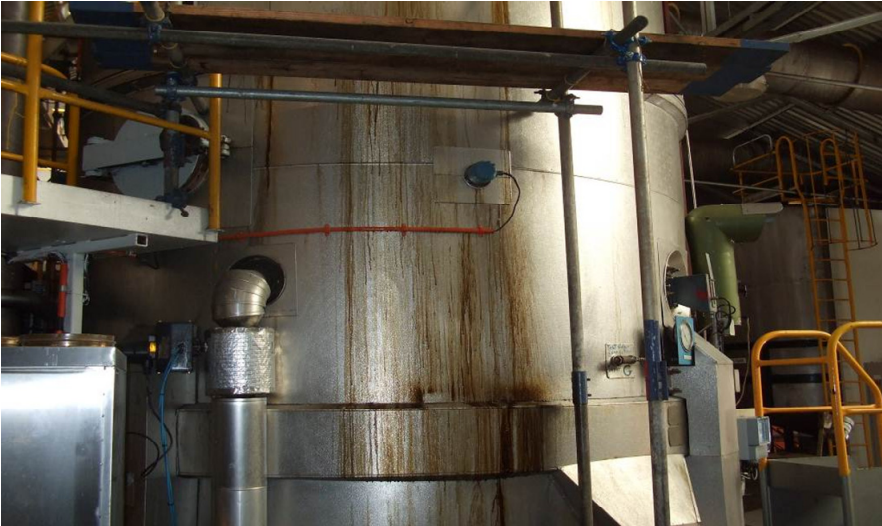
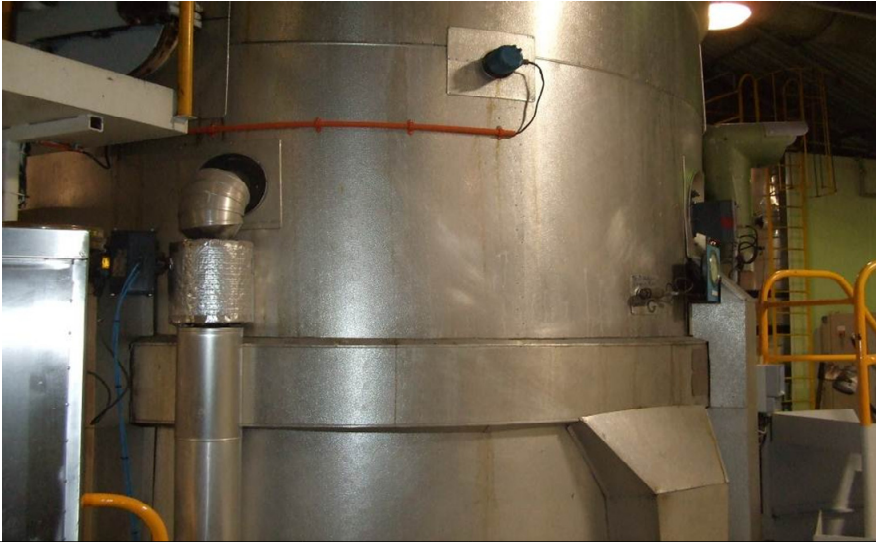
Team Name:	The Shift	Location:		Initiated Date:	7/3/12
Team Type:	OEM 2	Item:	G Pan	Completed Date:	4/4/12
Initiator:					
1. Problem (Plan)					
G Pan low vacuum , Leak contaminating insulation, floor and Silo sugar sampling.					
2. Current Situation (Plan)			3. Proposed Change / Approved Improvement (Do)		
Photo:

Improvement Target:	Identify, Repair and clean syrup leaked onto insulation and cladding. Improve Pan Vacuum.		Cost:	\$200	Expected Saving: Over \$30,000
4. Results: (Check)			5. Future Actions: (Act)		
Vacuum improved to 27.5" from 25.5". Pan boiling fast and efficient. Leak contaminating insulation and floor repaired.					
Approved by:		Shift A	Shift B	Shift C	Shift D
Team Leaders to sign off acceptance of Proposed Change					
CTPM Australasia					Page 15
